UIL HOLDINGS CORPORATION

*Connecticut Legislature
Tropical Storm Irene Hearing
September 19, 2011*

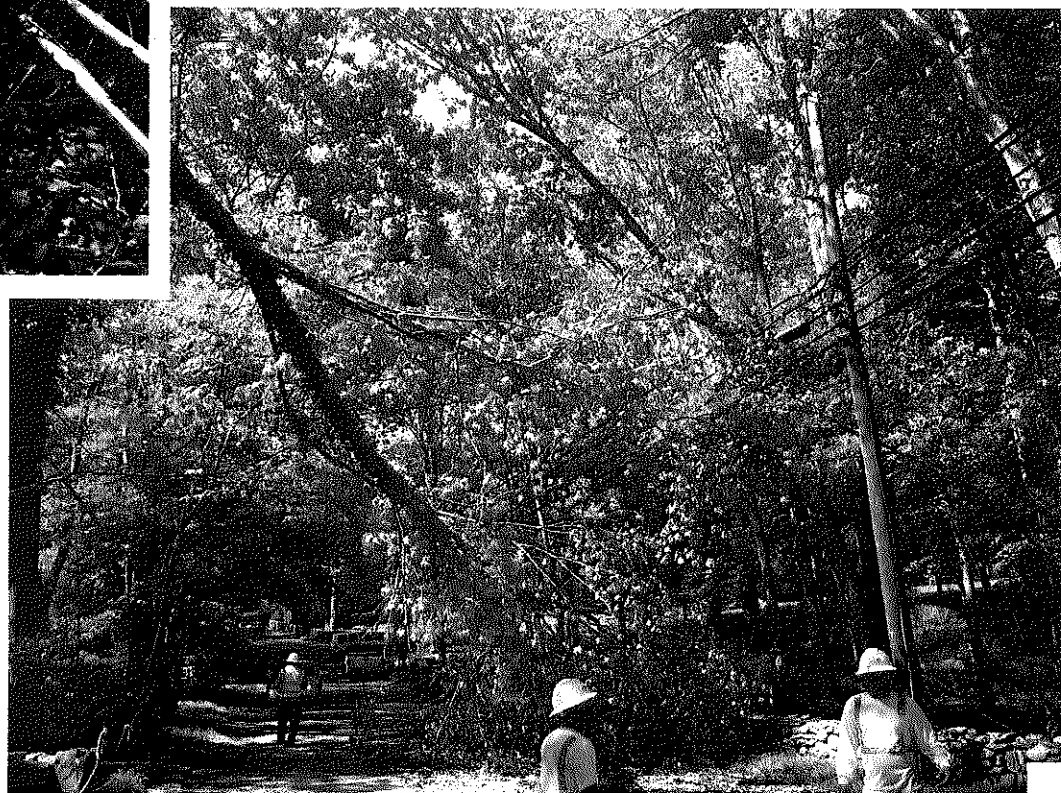
- Ferncliff Rd., Fairfield, CT
- Pole down
- Electric wires down
- Phone/Com wires down
- UG service to house damaged
